SB-01-12-23-1 Rev A

Elevator Idler Fatigue Cracks

MODEL- Ranger R7

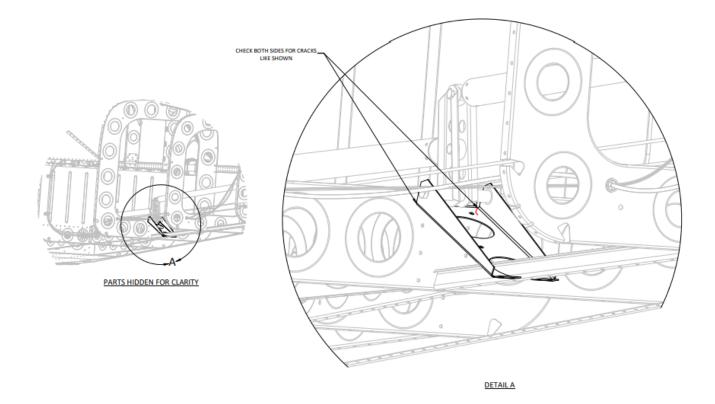
Inspect the critical flanges as shown in Figure 2 and Figure 3. If any cracks are present, contact Vashon Aircraft Support for corrective action until a subsequent bulletin is released.

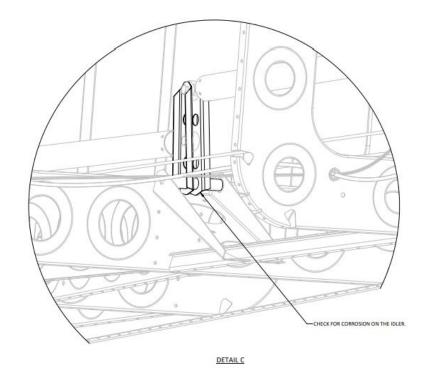
Figure 4

Corrosion on the idler, as shown in figure 4, is noteworthy but not indicative of a safety concern.
