Nose Gear Leg Weld Cracks

EFFECTIVITY**MODEL-** Ranger R7**SERIAL NO:** ALL AIRCRAFT IN THE RANGE OF: **10131-10171****REASON**

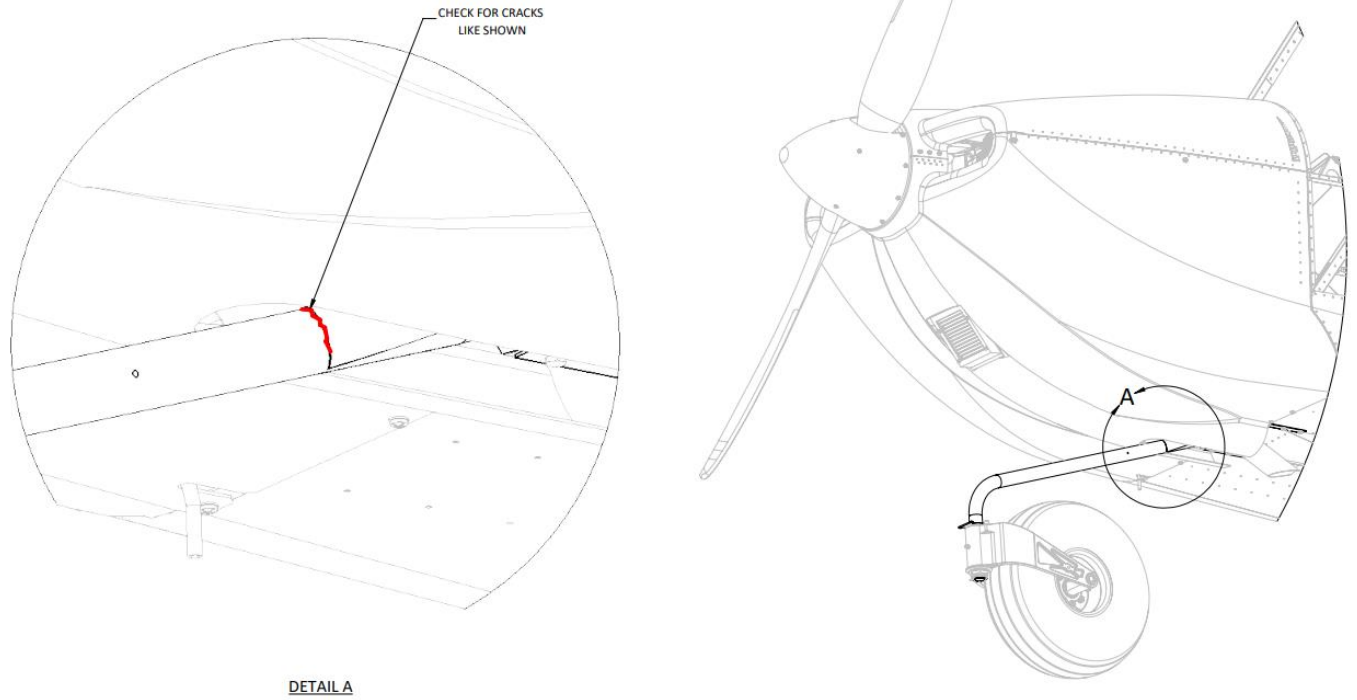
Figure 1

Inspect the landing leg as shown in Figure 1. An example of what a crack looks like is shown in Figure 2. "Chipping" of the paint is a strong indication of a metal fatigue crack. If any cracks are present, contact Vashon Aircraft Support for corrective action:

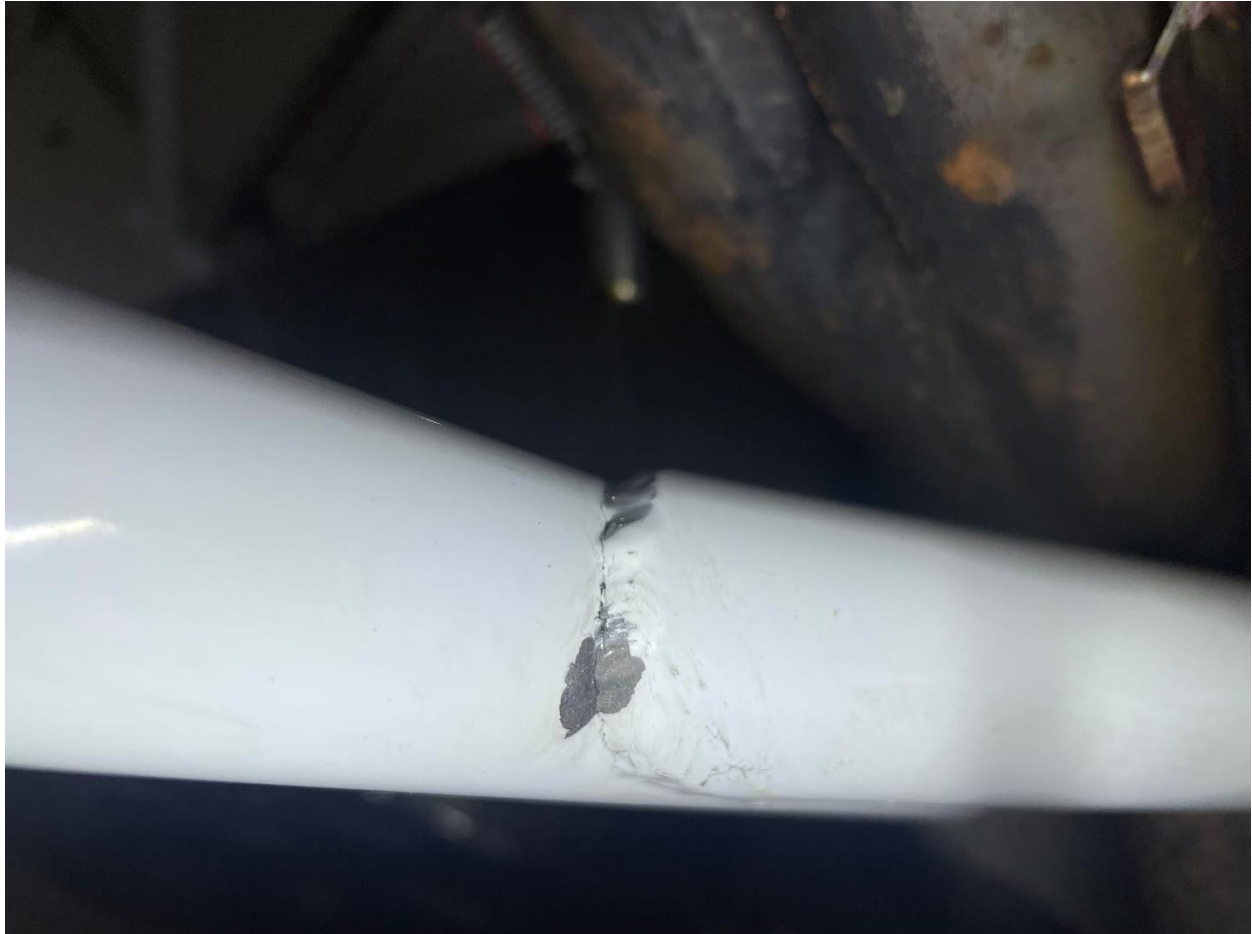
Figure 2

Fatigue cracks have been identified on the welded connection of the nose gear landing leg. This is due to insufficient weld penetration between the steel tubes. If the crack is left to propagate this could lead to a failure of the nose landing leg.
