SB-06-13-23-1 Rev A

**SUBJECT**

Nose Gear Leg Weld Cracks

**EFFECTIVITY****MODEL-** Ranger R7**SERIAL NO:** ALL AIRCRAFT IN THE RANGE OF: **10131-10171****REASON**

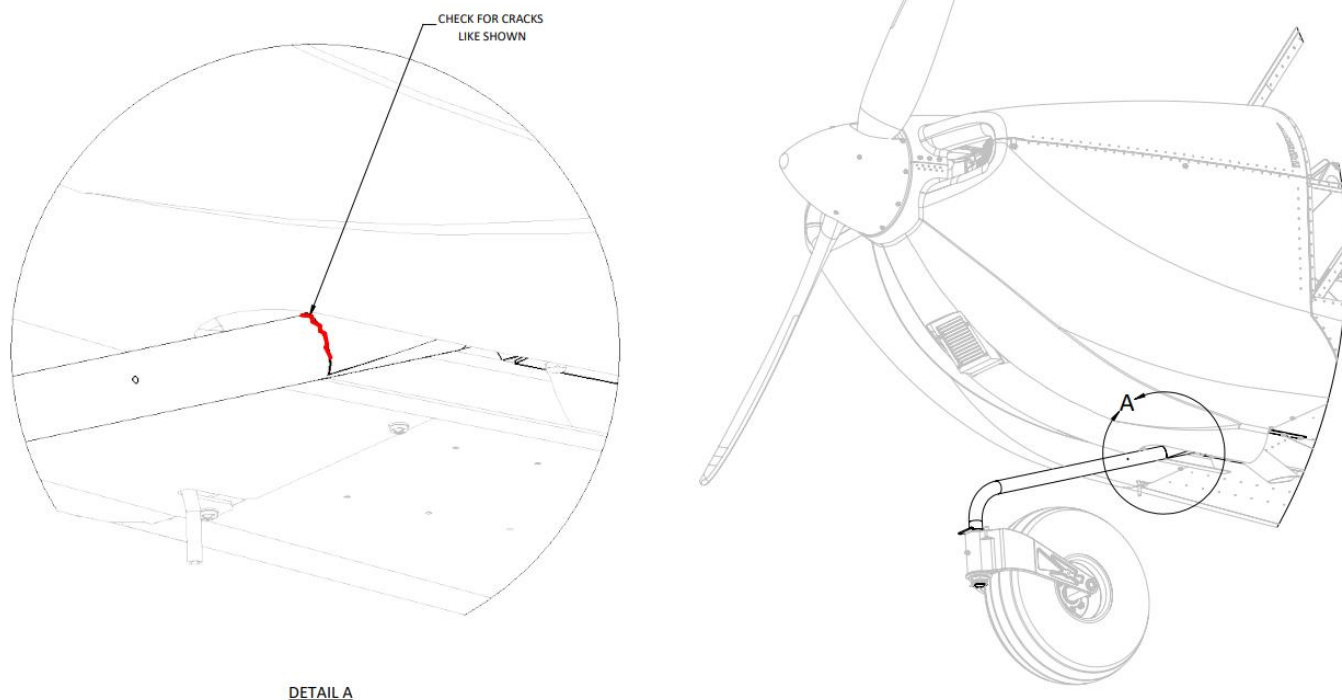
**Figure 1**

Fatigue cracks have been identified on the welded connection of the nose gear landing leg. This is due to insufficient weld penetration between the steel tubes. If the crack is left to propagate this could lead to a failure of the nose landing leg.

Inspect immediately. After that, inspect in 25hr intervals until 100hr inspection. After this, the inspection interval can default to each annual inspection.

Inspect the landing leg as shown in Figure 1. An example of what a crack could look like is shown in Figure 2. "Chipping" of the paint is a strong indication of a metal fatigue crack. If any cracks are present, contact Vashon Aircraft Support for corrective action:
