SERVICE BULLETIN

SB-12-06-22-1 Rev C

Engine Mount Fatigue Cracks

MODEL- Ranger R7

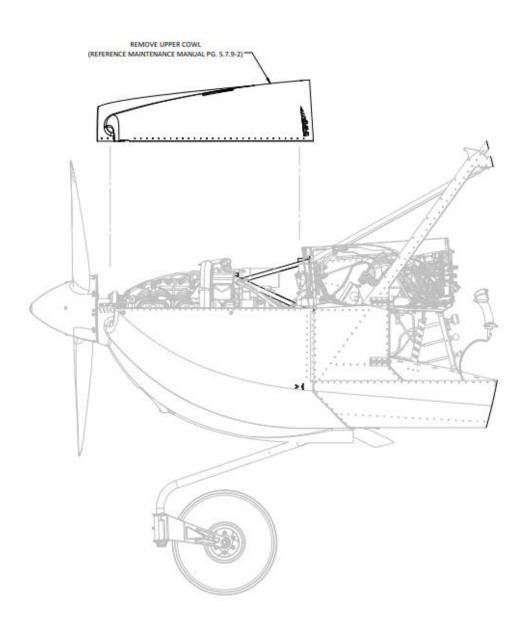
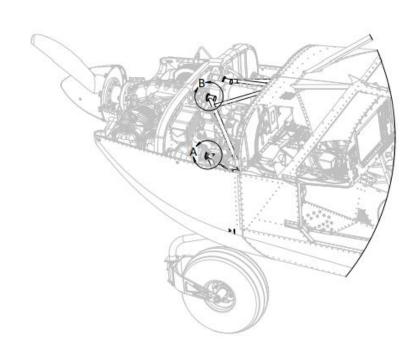
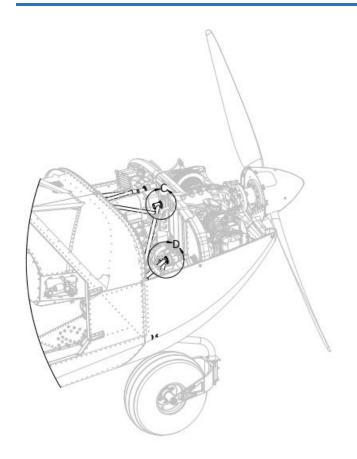
Appendix A: Inspection Of Engine Mount

Fatigue cracks have been reported on the engine mount lug welds caused by insufficient weld fillets. This issue has been traced back to batch of aircraft with serial number identified above.

Inspect the engine mounting weldment for cracks.

Inspect weldment as shown in Appendix A. If any cracks are present, DO NOT continue to fly – Contact Vashon Aircraft Support for corrective action.
