Fuel Line Chaffing

**EFFECTIVITY:****MODEL:** Ranger R7**SERIAL NO:** SN 10131-10250

Chaffing has been identified on the aluminum fuel delivery line(s) that feed from the main tanks to the header tank, due to the proximity of the glareshield pass-through hole. In one instance, the chaffing resulted in a leak of the fuel line, which caused fuel to drip into the avionics bay.

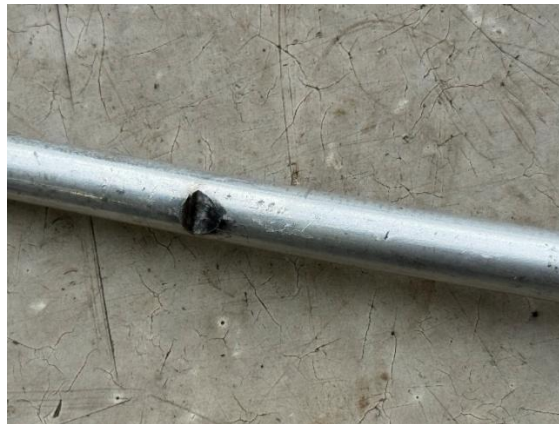
**Figure 2**

Remove the black wrap covering the vee brace tubes and inspect the underside of each fuel line in the cockpit for chaffing or fuel residue. Figure 2 shows an example of the punctured fuel line. If any leaks are present, or chaffing is severe, contact Vashon support for replacement fuel lines. This service bulletin has been complied with when the inspection has been completed, and edge grommeting has been installed.
