SB-01-12-23-1 Rev A

Elevator Idler Fatigue Cracks

MODEL- Ranger R7

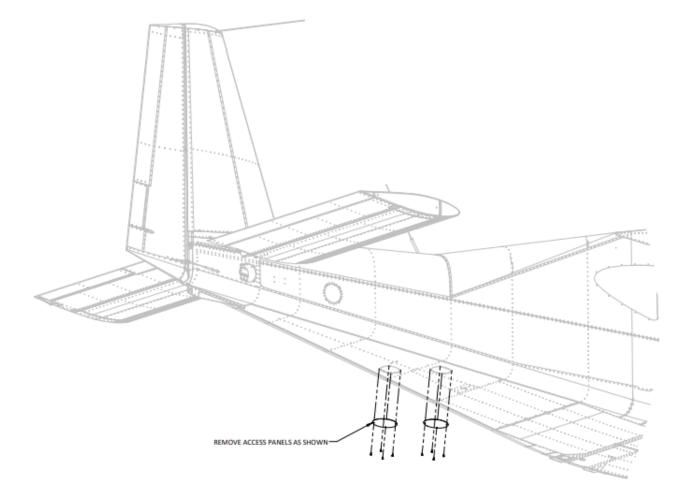
Figure 1

Fatigue cracks have been reported in the field on the bracketry supporting the elevator pushrod idler assembly. This is due to high loads from the elevator pushrod fatiguing the bracket through cyclic loading. It is also believed that corrosion of the idler also contributes to this issue. If a crack continues to propagate without proper attention, this could lead to slop in the elevator control system and possibly failure of the supporting bracketry.

Inspect bracket and fuselage ribs for cracks. Also note on condition of idler assembly.

Inspect the critical flanges as shown in Figure 2 and Figure 3. If any cracks are present, contact Vashon Aircraft Support for corrective action until a subsequent bulletin is released.
